SOUTH 4 GROUP FIRE

Port Neches, TX

Property Assessment Summary

December 9, 2019

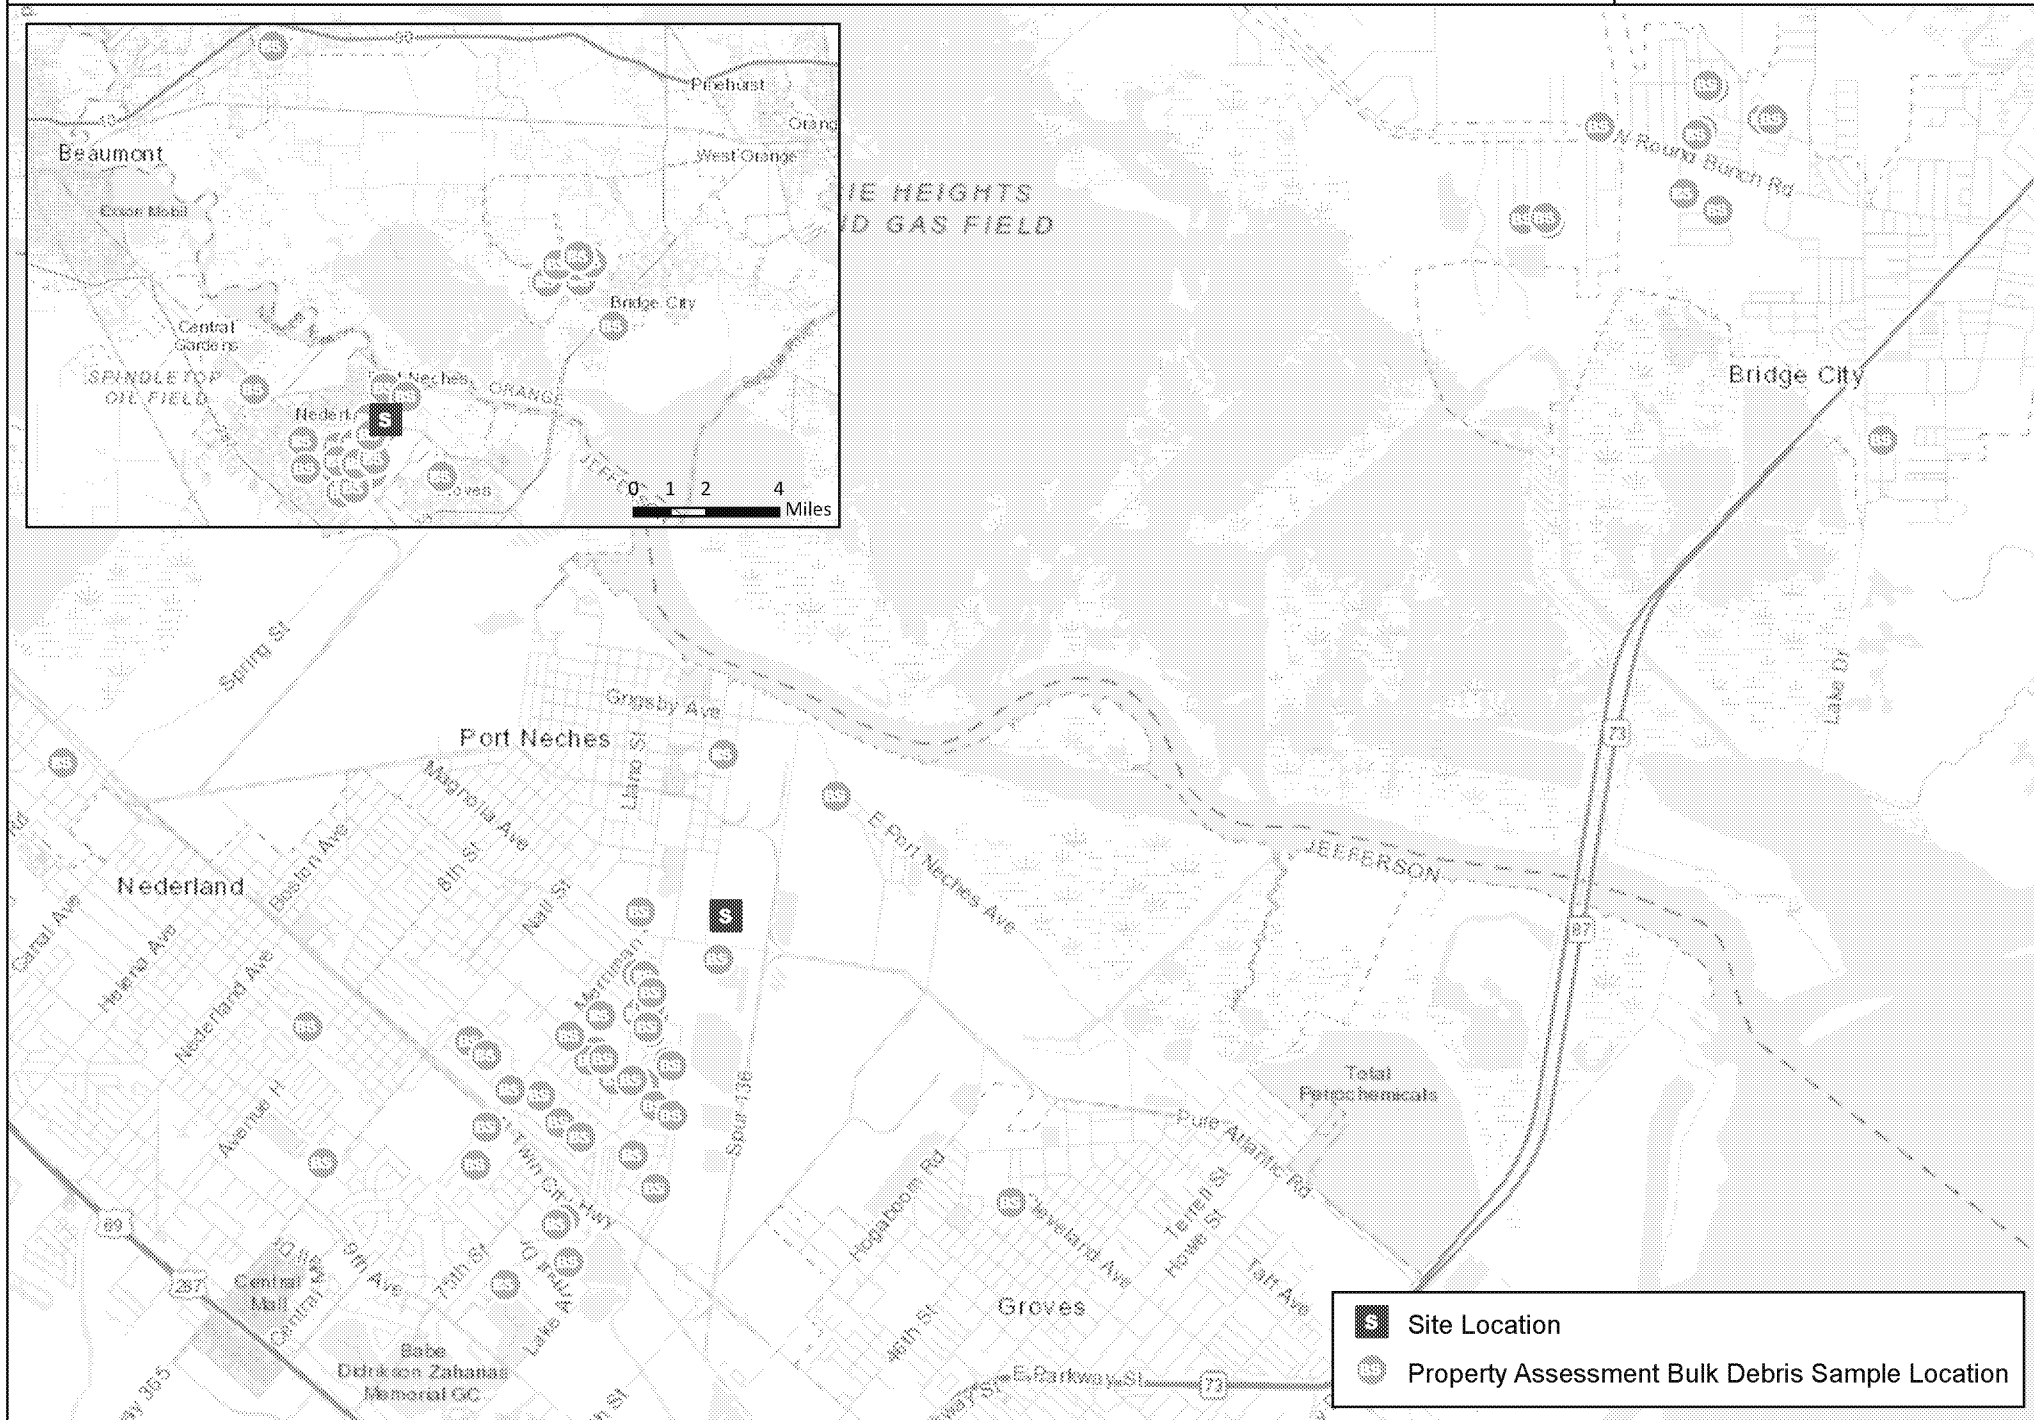
Preliminary Asbestos Bulk Debris Sampling Property Assessment Locations

South 4 Group Fire | Port Neches, TX | 12/01/2019 - 12/08/2019

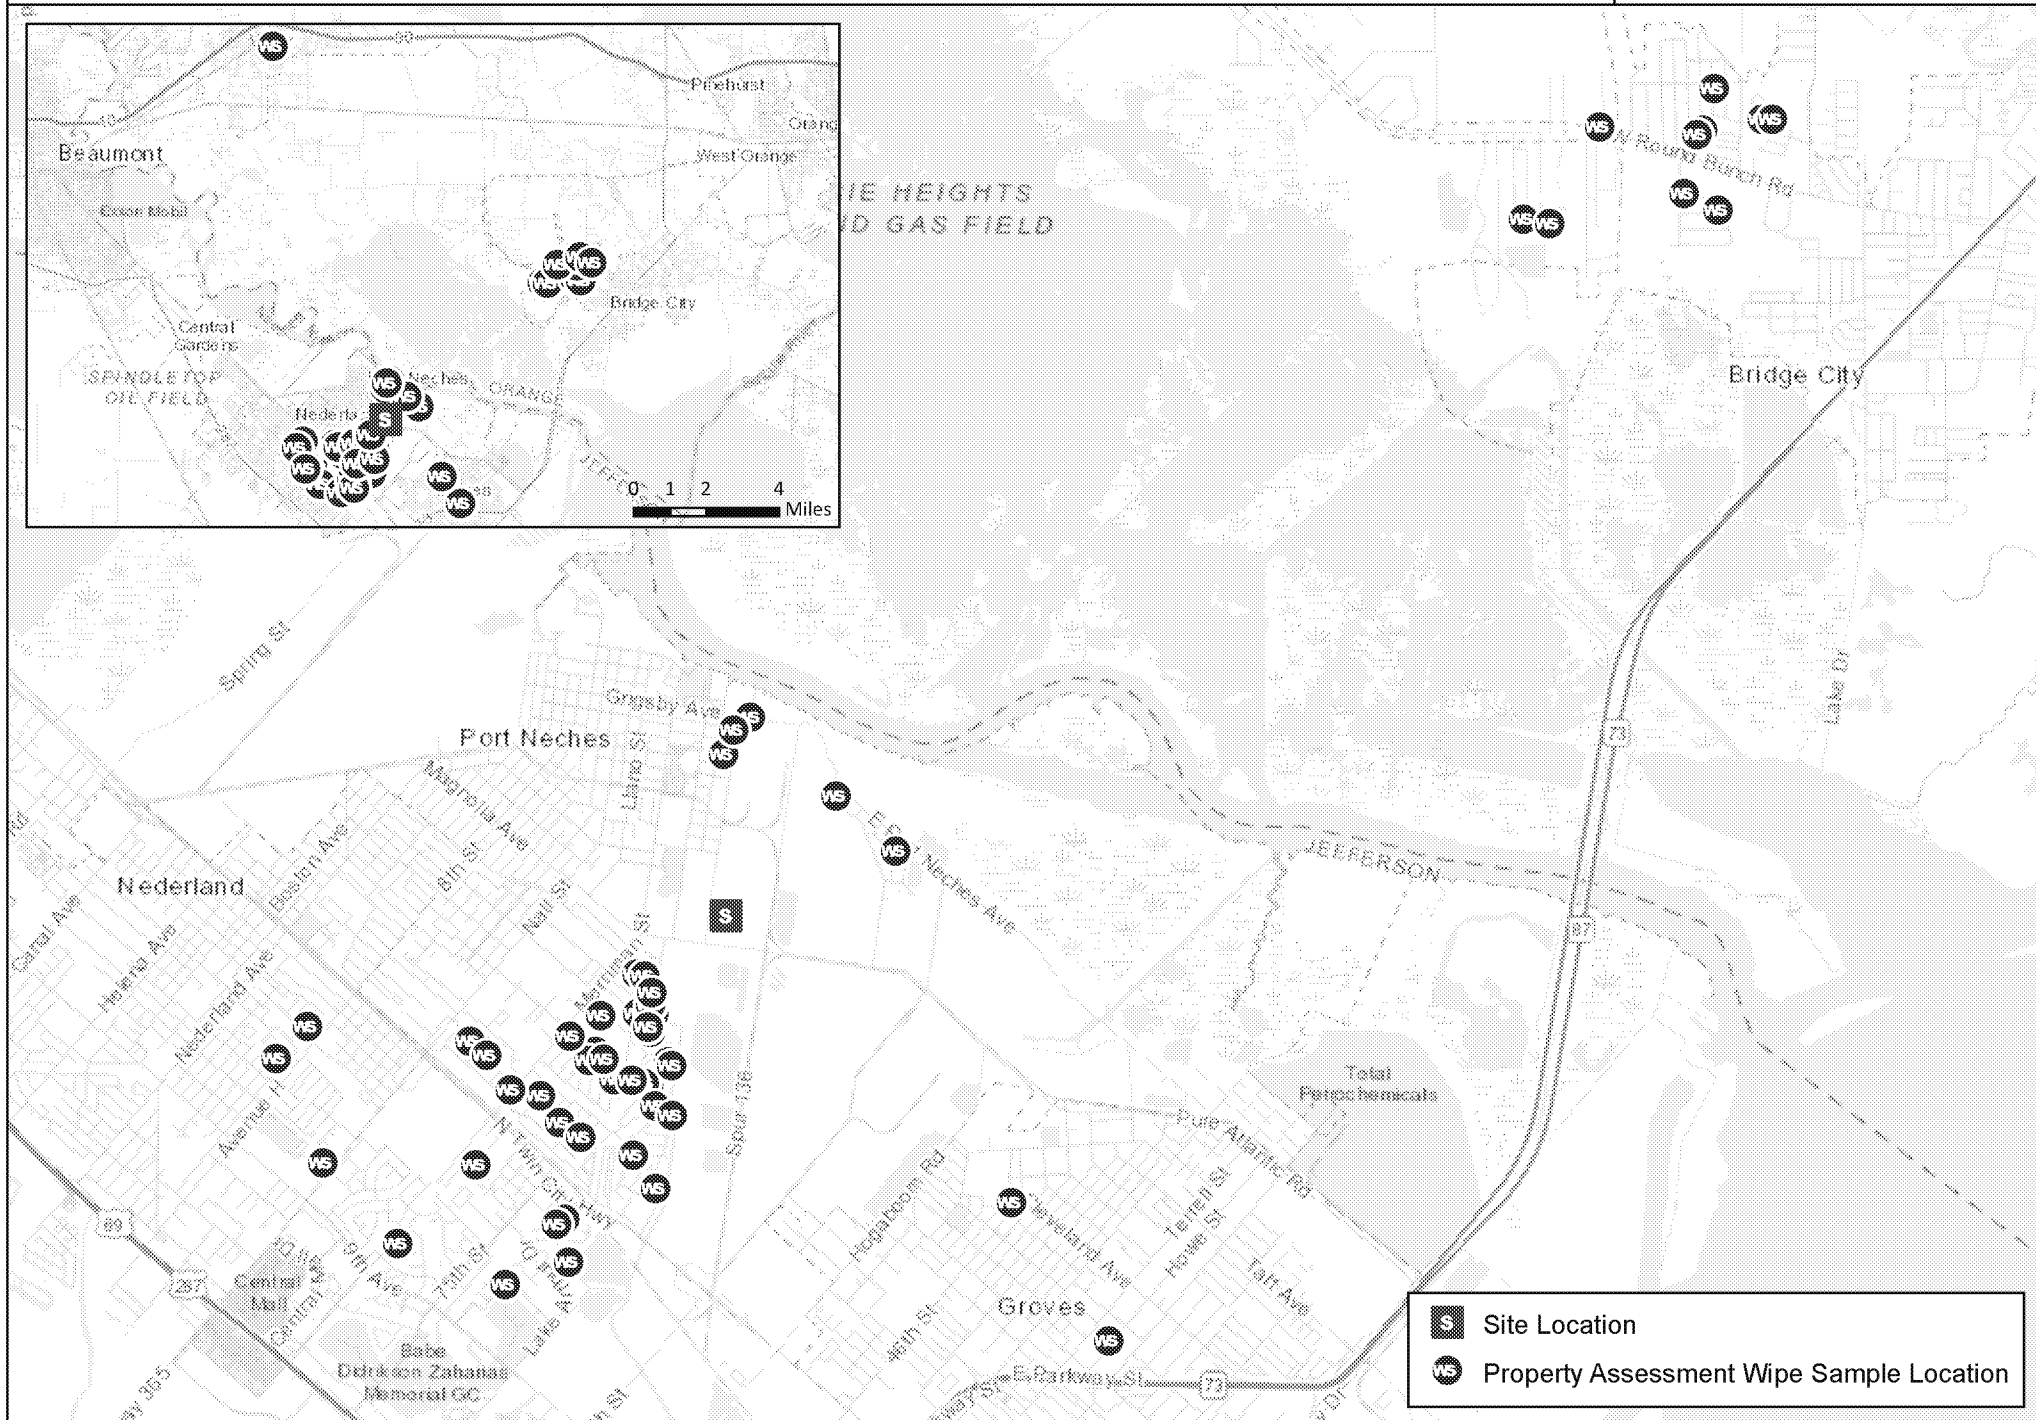
Preliminary Asbestos Wipe Sampling Property Assessment Locations

South 4 Group Fire | Port Neches, TX | 12/01/2019 - 12/08/2019
